Model: 175T – 750T

Jul. 10, 2018

Product Bulletin # **TDS-183**

Inspect Die Blocks

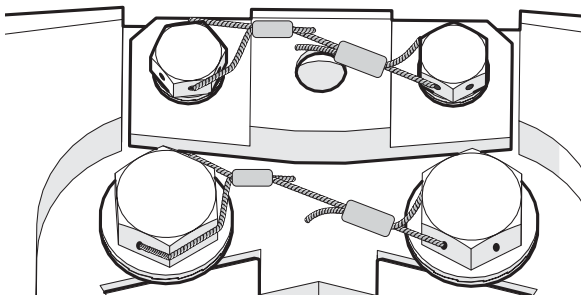
Figure 1: Safety Wiring for Bolts on Die Block (Top)

- Replace all damaged components with new components.
- Replace all loose or damaged fasteners with new fasteners.
- When replacing fasteners, add Loctite[®] or equivalent to the fasteners and re-torque to the appropriate torque value as per **Canrig Capscrew Torque Values specification ENG 725**.
- Safety wire all fasteners as per **Canrig Safety Wiring specification ENG 701**.

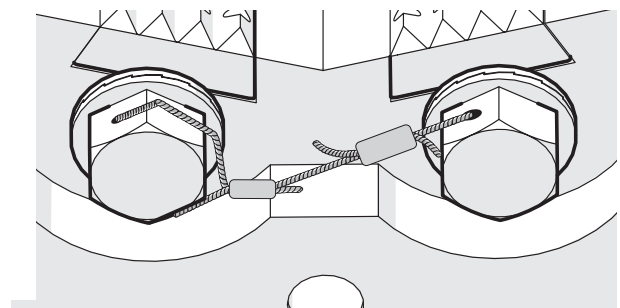
Figure 2: Safety Wiring for Bolts on Die Block (Bottom)
