Model: EXI 600 Top Drives

Product Bulletin # TDS-207 v 1.0

Alert

Junction Box to 600HP Motor Fasteners

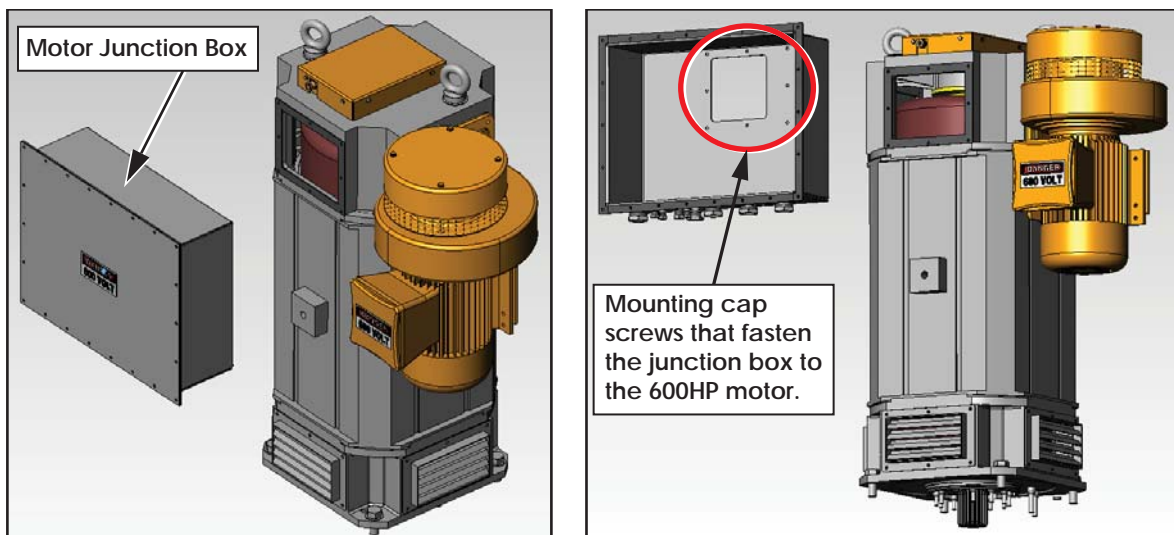
An incident occurred involving a Canrig top drive model TESCO EXI 600 where the cap screws that fasten the high voltage junction box to the 600HP motor came loose or broke off during a period of rough drilling.

Figure 1: Motor junction box showing location of affected cap screws

Fasteners that fail to secure the junction box to the motor can result in two potential hazards – dropped object incident and high voltage arcing.

1. Open the junction box cover.
2. Inspect the motor junction box mounting cap screws and note the size, condition and if any retention methods are in place.
3. It will be necessary to replace the 5/16" fasteners as soon as possible. If the fasteners are 5/16" UNC, loosen them slightly then re-tighten using a 3/8" drive torque wrench. Tighten the fasteners to 25 lb-ft, install safety wire on the fasteners and secure the junction box assembly with a safety cable 10281.
4. Re-install the junction box cover.
5. At the earliest possible service time, perform the permanent correction below.

- b. Drill the clearance holes in the junction box to 25/64" diameter to facilitate the new 3/8" fasteners.
 - c. Drill the mounting holes in the motor out with a 5/16" drill bit, and tap the holes using a 3/8" 16 UNC bottoming tap.
 - d. Complete the following step.
2. If the fasteners were already 3/8" UNC, determine the fastener grade:
 - a. If not Grade 8 or stainless steel, replace them with 3/8" - 16 UNC X 1-1/4" Grade 8 drilled head fasteners (Canrig P/N: 5965) with lock washers (Canrig P/N: 1066) and flat washers (Canrig P/N: 10340).
 - b. Apply Loctite® 243 (Canrig P/N: 17756) to the fasteners and tighten to 40 ft-lb.
 - c. Apply 0.032" stainless annealed safety wire (Canrig P/N: 2909) on all fasteners.
3. Re-install the junction box cover.

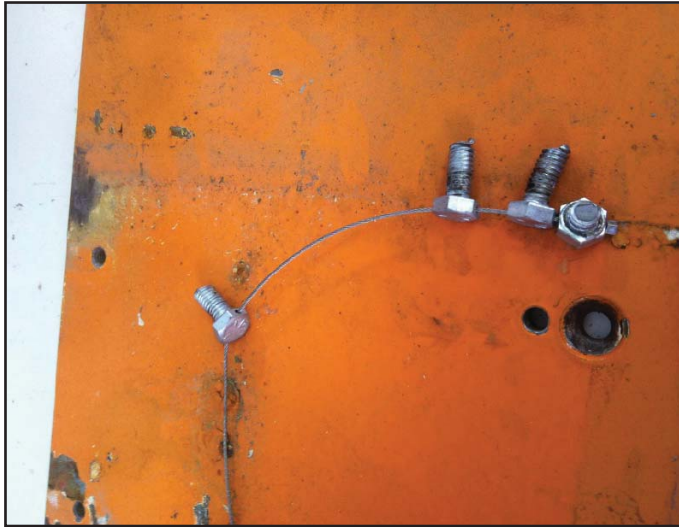
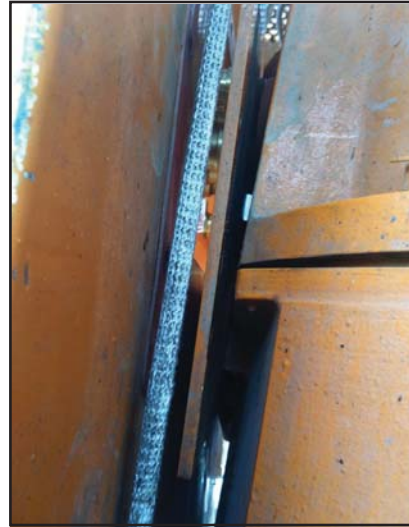
Figure 2: Bolts that have come loose or failed, causing the motor junction box to slip on the TESCO EXI-600 Top Drive
