Torq-Matic™ TM80 Tie Bar Crack

Issue

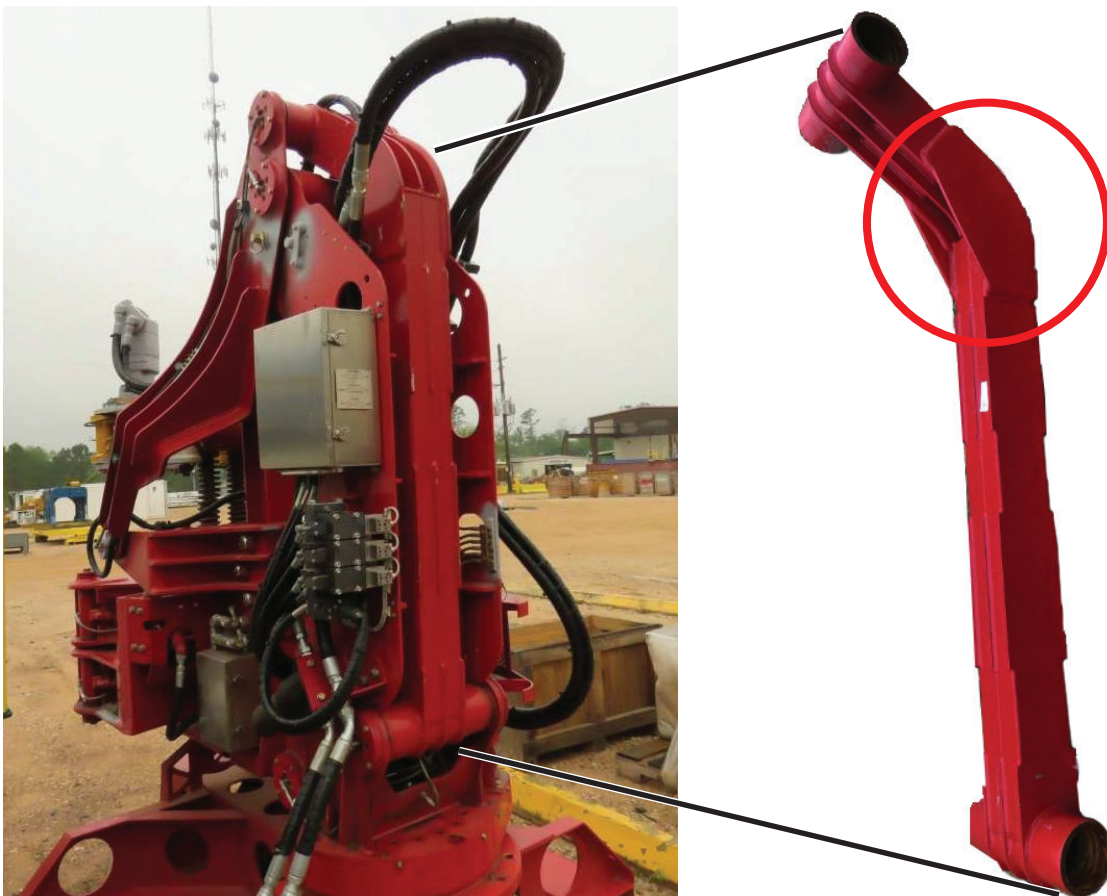
Canrig has been made aware of an instance where the Tie Bar for a TM80 has developed a crack. This may cause the overall wrench strength to weaken. The cause of the crack is under investigation. If necessary, Canrig will follow up with a bulletin with further recommendations. In the meantime, it is important for customers to visually inspect the Tie Bar along its entire length and where indicated below. If a crack is found, contact RigLine 24/7™ Support immediately.

Figure 1: Inspect the entire TM80 Tie Bar for cracks in the weld or material, especially the indicated area. Contact RigLine 24/7™ Support immediately if cracks are found.
